An object oriented approach for quantitative assessment of building damage in urban areas using very high resolution images

Anne-Lise Chesnel, Renaud Binet, Lucien Wald

Anne-Lise Chesnel, Renaud Binet, Lucien Wald. An object oriented approach for quantitative assessment of building damage in urban areas using very high resolution images. IEEE Urban Remote Sensing Joint Event 2007, Apr 2007, Paris, France. pp.1-5, 10.1109/URS.2007.371865 . hal-00464866

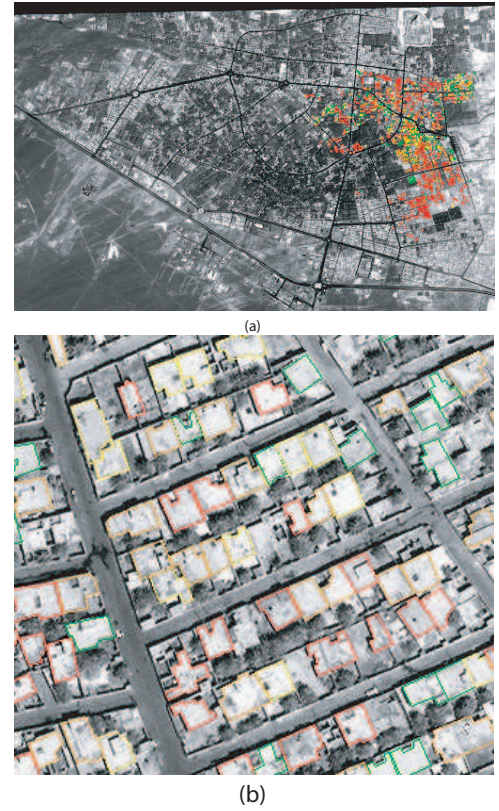
Fig. 1. QuickBird reference image (before the earthquake) of Bam. The buildings footprint of the corresponding reference database is overlaid. (a) : entire scene; (b) : image extract. Colour legend of the database: Green = damage grade 0; Yellow = damage grade 3; Orange = damage grade 4; Red = damage grade 5. Images: copyright DigitalGlobe 2003, 2004.

We have constructed one database per case to serve as a reference to assess the performances of our approach. It contains the footprints of the roofs of the buildings prior to the disaster. The footprints were manually extracted from the reference images. For example, in the case of the Bam earthquake, 2168 buildings are contained in this database, and they are located in the eastern part of the town. An extract of the Bam QuickBird reference image on which the footprints of the buildings have been overlaid is presented in figure 1. The other databases contain respectively 610 buildings in Boumerdes, 725 buildings in Ryongchon and 937 buildings in Muzzafarabad.
